**Flood Control Project Maintenance
Levee Inspections**

Fall 2009 Levee Maintenance Deficiency Summary Report

Reclamation District No. 0001 Union Island

Waterway						Bank	Unit Miles	Inspection Start/End	Inspector	
Unit No. 01 Old River						Right	1.15	10/15/2009 10/15/2009	John Paasch

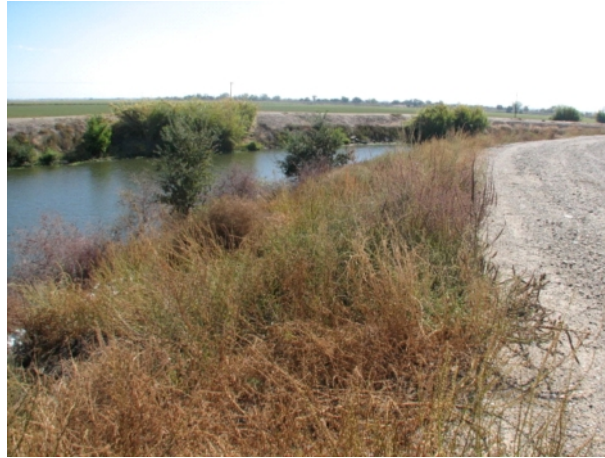
jpaasch_20091015_13.jpg

Levee Mile Report Line	3
Start Levee Mile	1.05
End Levee Mile	1.09
Location	Water Side
Category	Earthen Levee
Item	Vegetation

Photo of tumble weeds on water side. Visibility and access are obstructed.

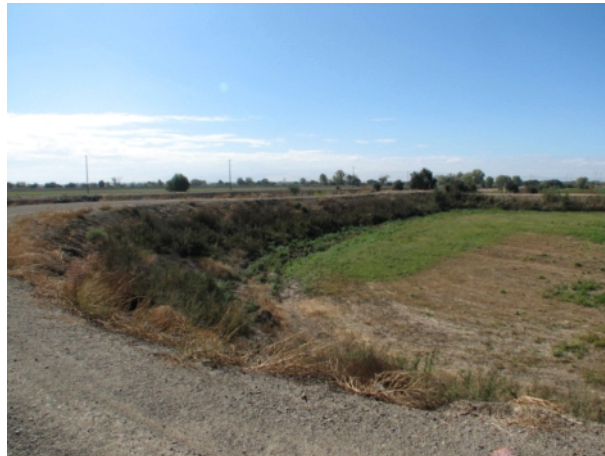
jpaasch_20091015_14.jpg

Levee Mile Report Line	4
Start Levee Mile	1.07
End Levee Mile	1.15
Location	Land Side
Category	Earthen Levee
Item	Vegetation

Photo of vegetation on landsideslope and toe.
